## ***Site Information***

### **A. Site Description**

Rancho Cantera, LLC. operates a 1400 head dairy in Stephenson County Illinois.

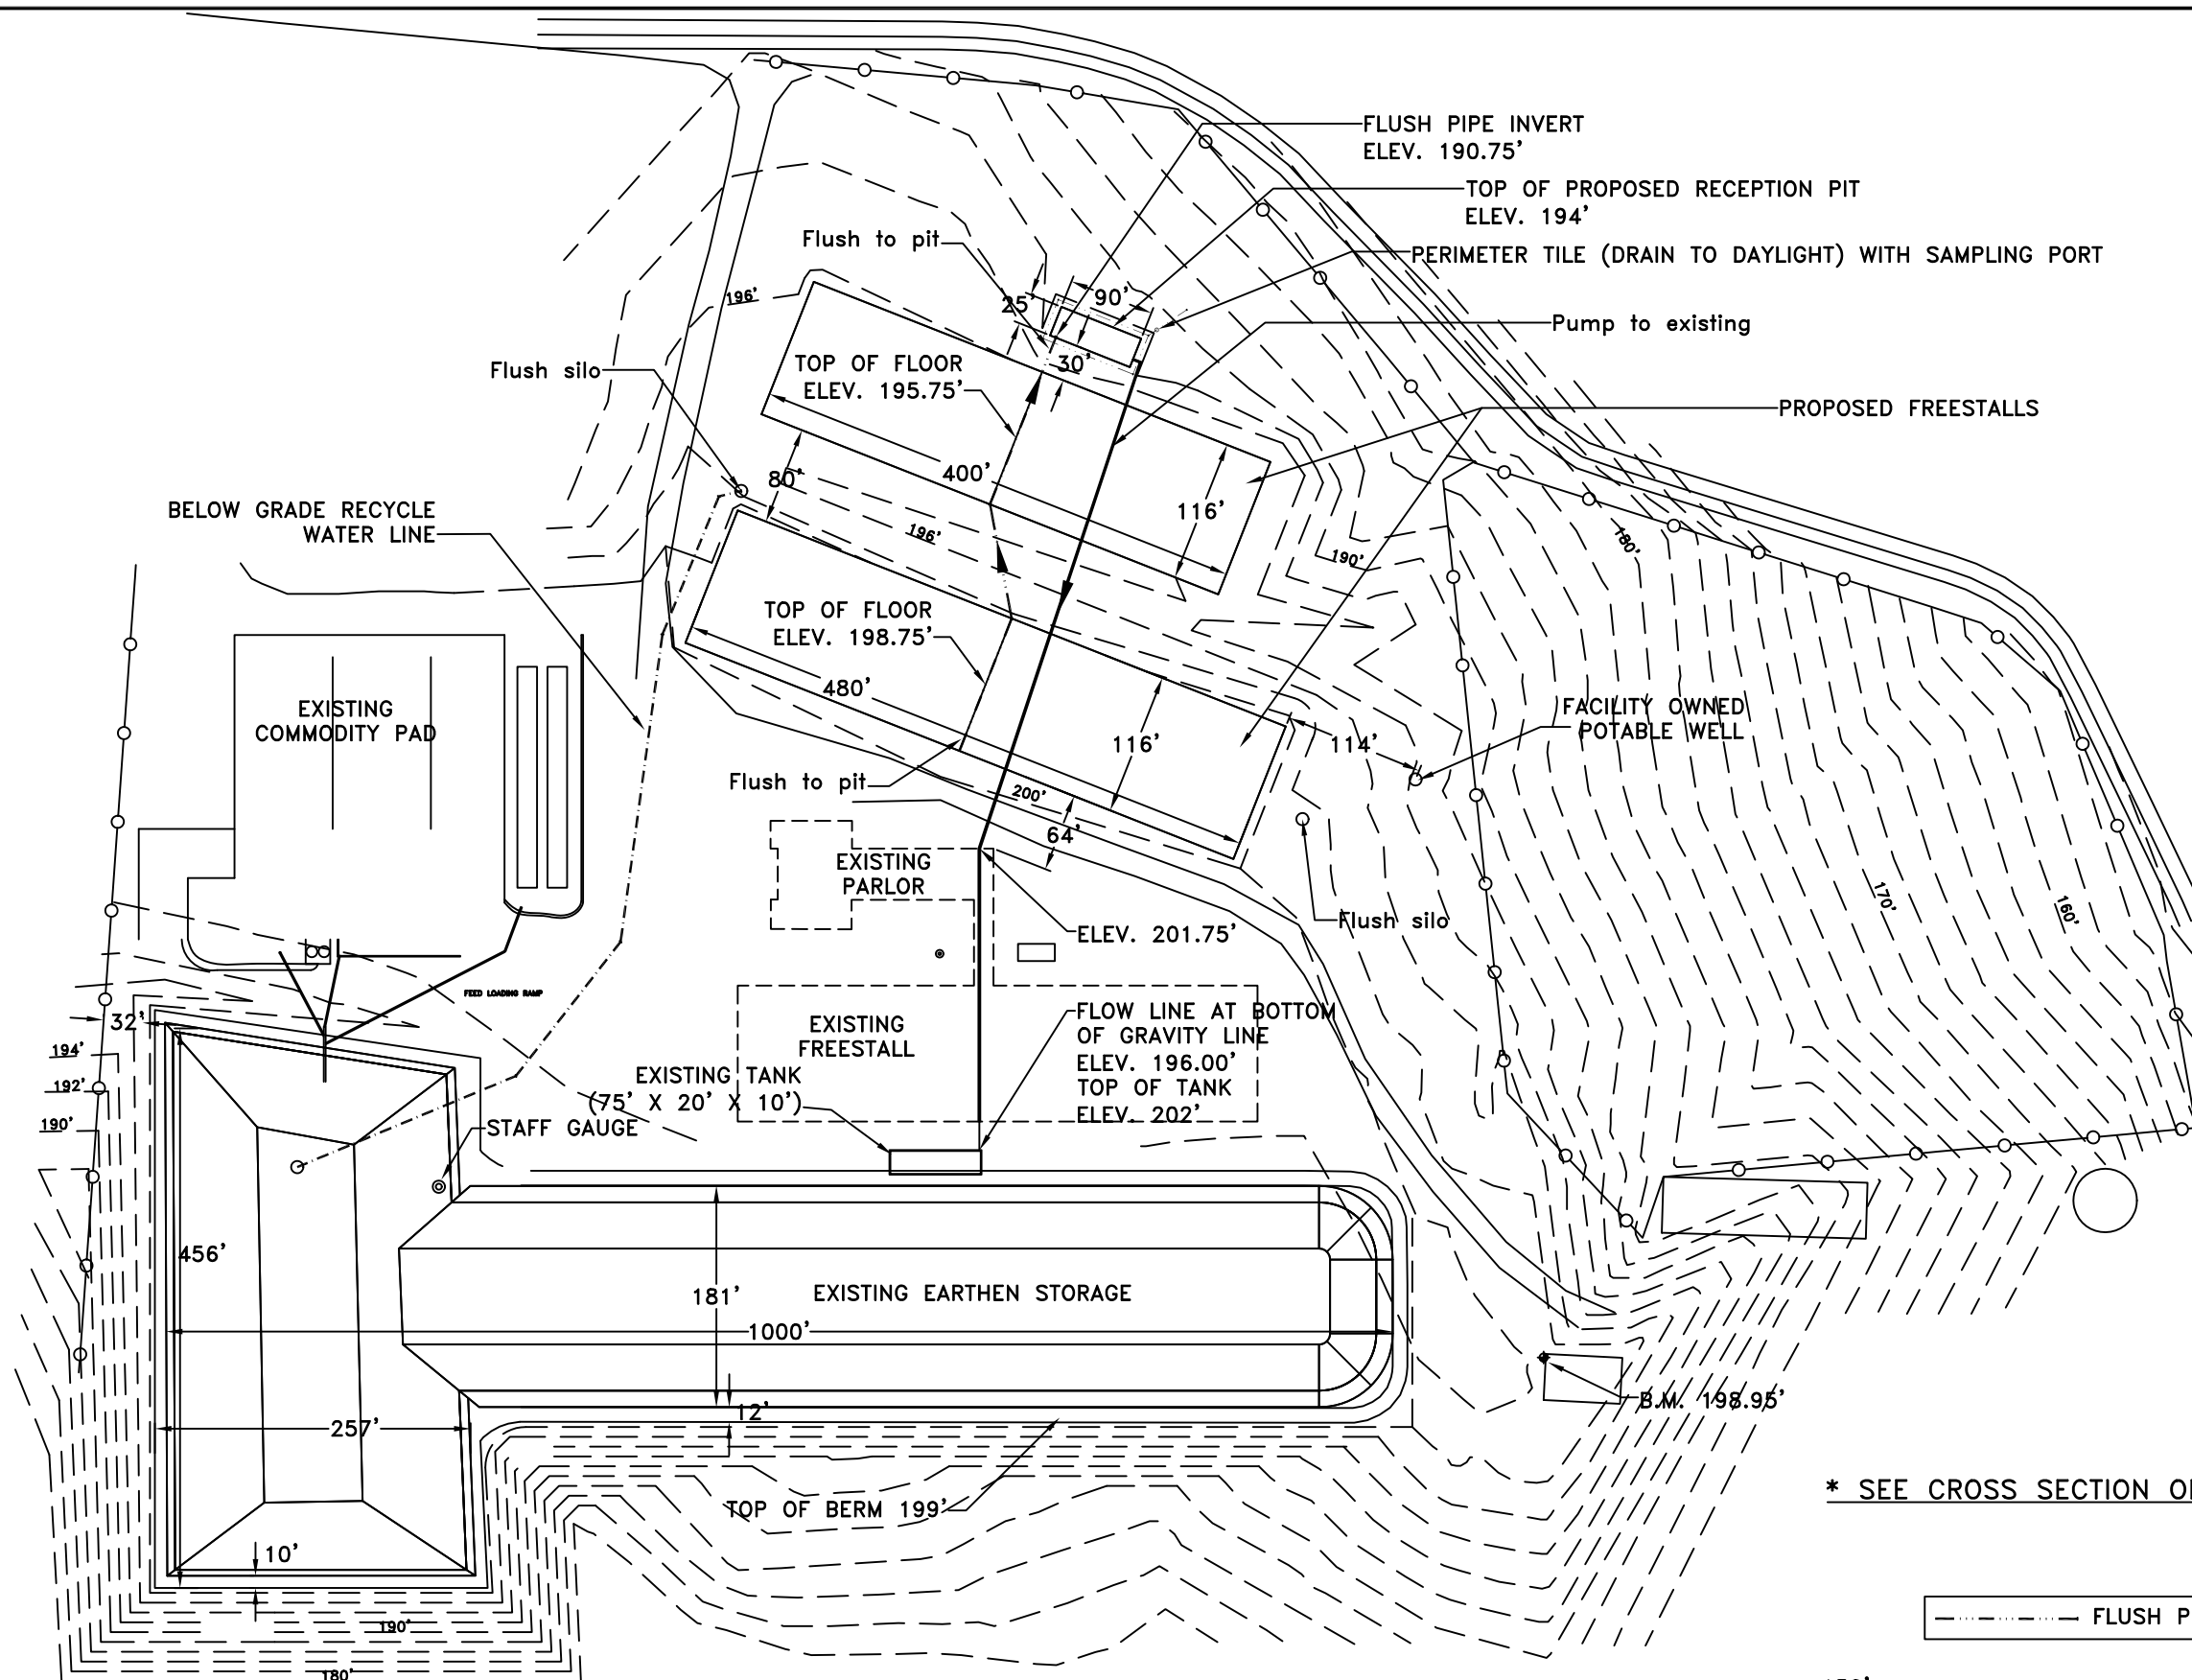
The dairy consists of a 500 head freestall building that measures 423' x 111', a 600 head proposed freestall building that measures 480' x 116' and a 400 head freestall building that measures 400' x 116'. All animal housing structures can be seen on the plot plan on the following page. In addition to the freestall buildings the facility has an existing earthen storage that measures 181' x 743' and 456' x 257'. All waste from the facility is to be flushed to the earthen storage.

— — — — — FLUSH PIPE
